WL-TR-91-4032
DOT/FAA/CT-91/23
VOL II, Part 2

COMPOSITE FAILURE ANALYSIS HANDBOOK
VOL II - TECHNICAL HANDBOOK
PART 2 - ATLAS OF FRACTOGRAPHS

R.J. Kar
Northrop Corporation
One Northrop Avenue
Hawthorne, California 90250-3277

February 1992

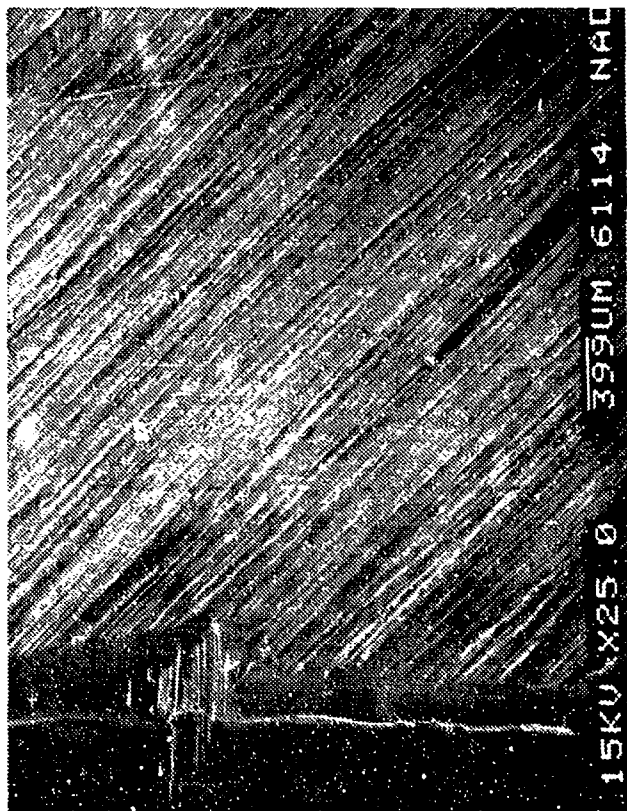
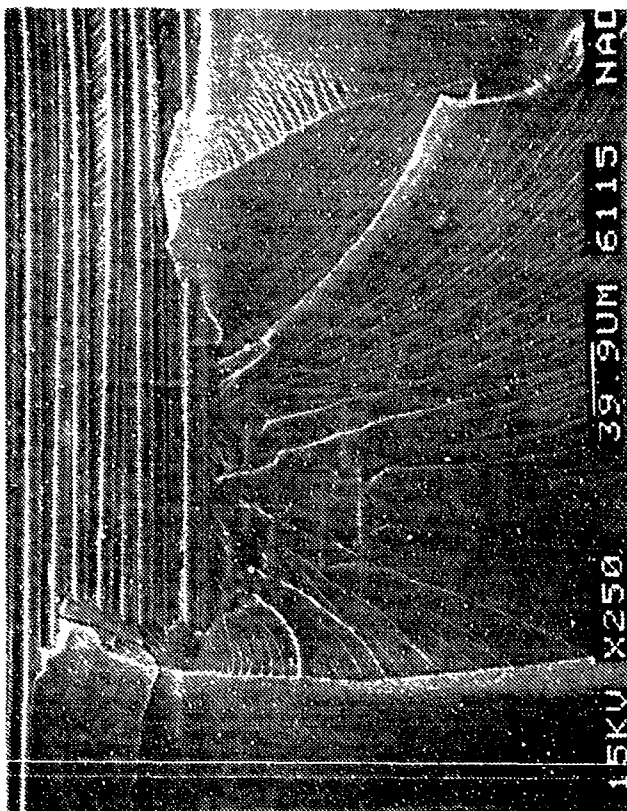
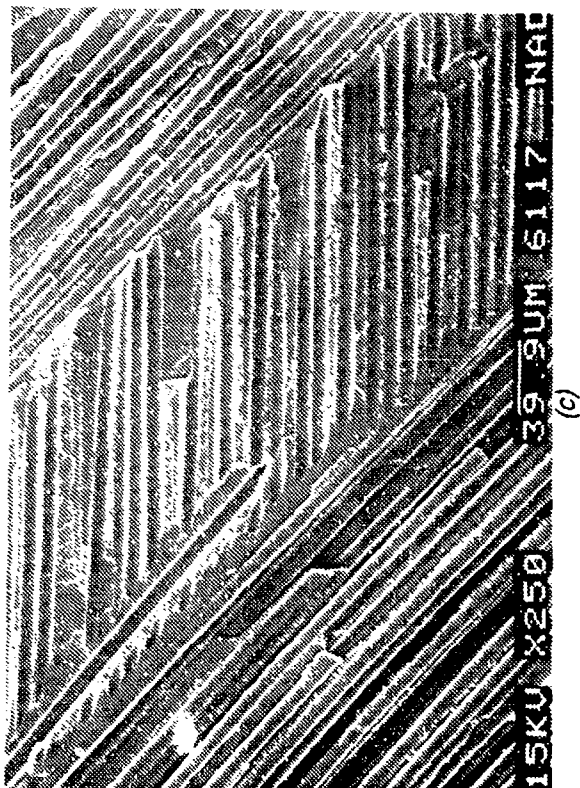
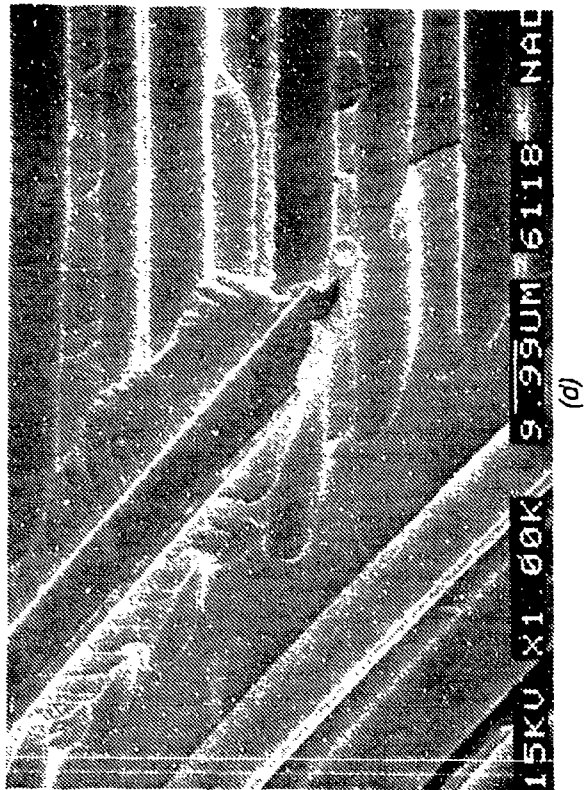
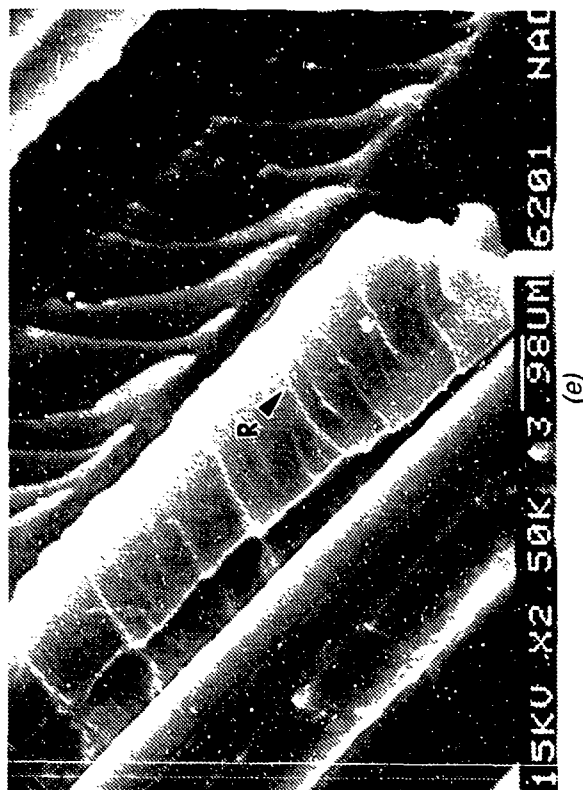
Figure 2-192. SEM Photographs of Interlaminar Mode I DCB Spectrum Fatigue Fracture in AS4/3501-6 Gr/Ep - [+45/0/-45]_{4s}
 (a) Macro photograph of Fracture
 (b) Initiation in Resin-Rich Area in Precrack Region

Figure 2-192. (Continued)
 (c), (d) Low and Intermediate Magnification
 Photographs Showing Fracture Traversing from
 45 Degree Ply to 0 Degree Ply and Back in
 Crack-Growth Region
 (e) High Magnification Photograph Showing Regular
 Array of Rivers (R) Oriented Toward CD
 CD = Crack-propagation direction

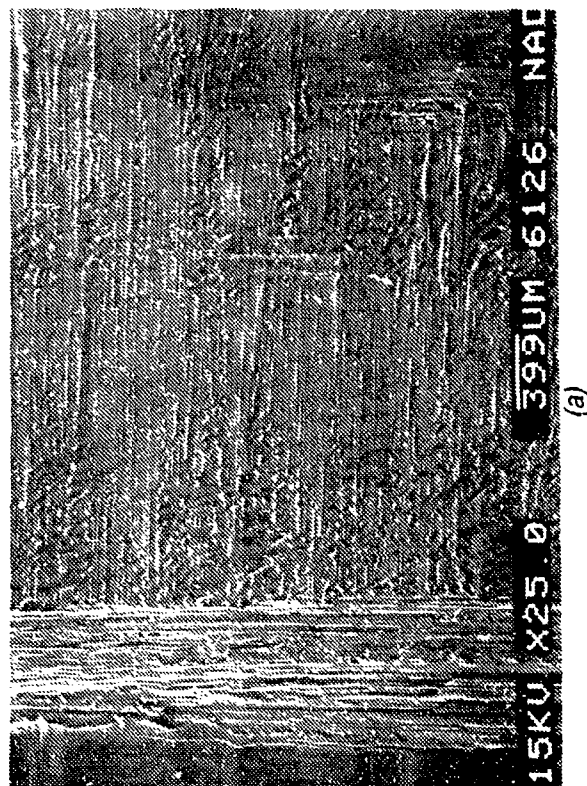
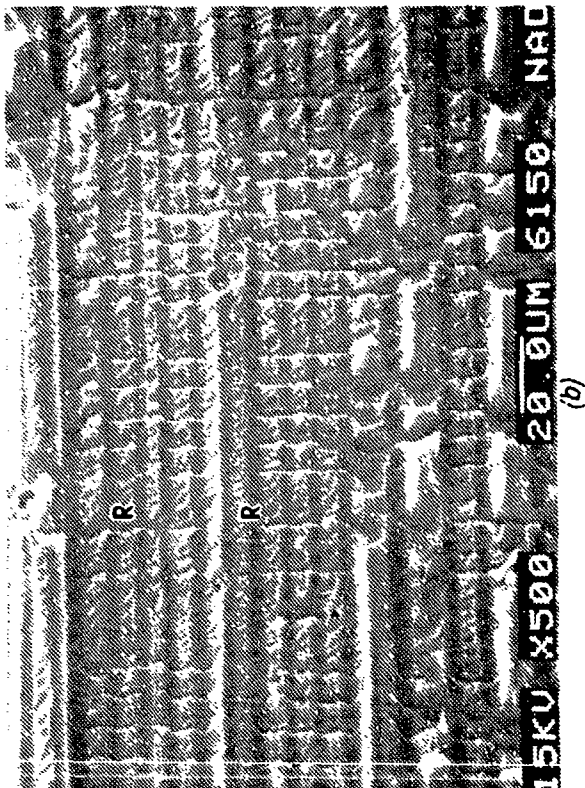
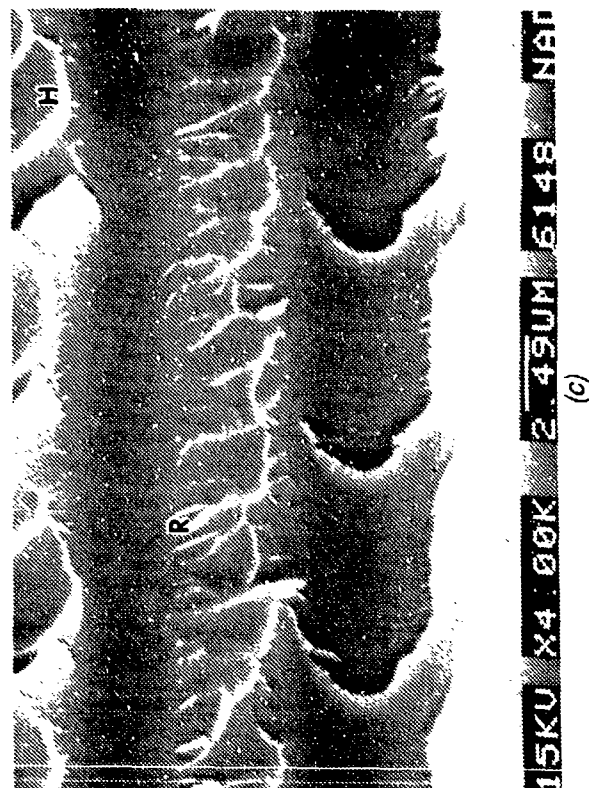
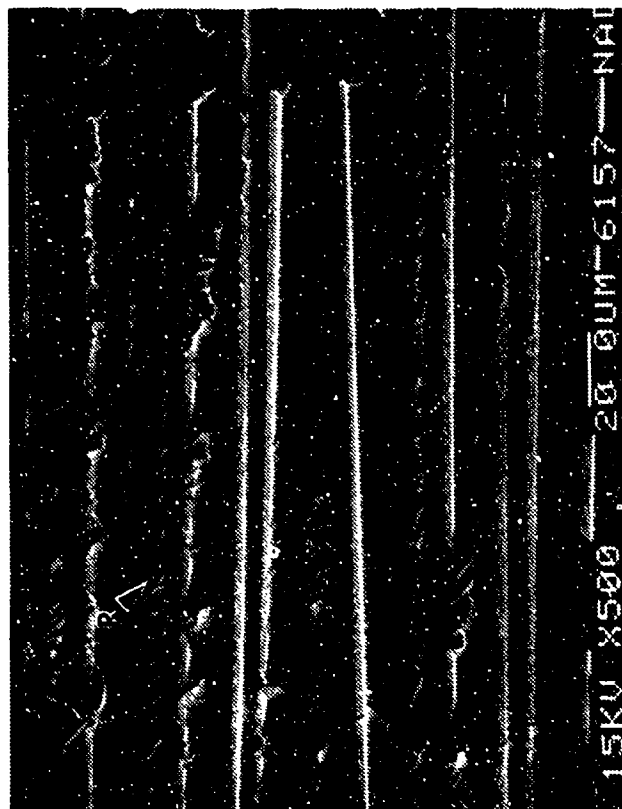
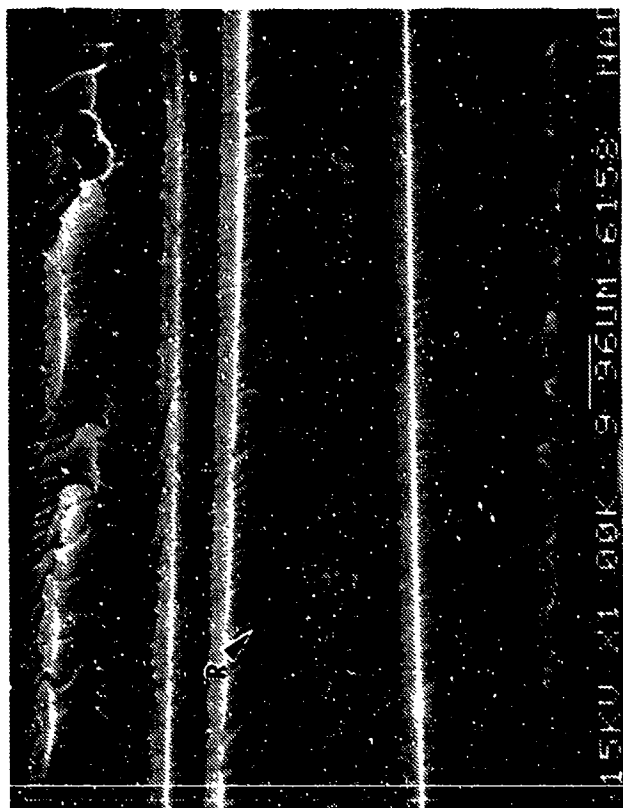
Figure 2-193. SEM Photographs of Interlaminar Mode I DCB
Spectrum Fatigue Fracture in AS4/3501-6 Gr/Ep -
[0/90]_{6S}
(a) Macro photograph of Fracture
(b), (c) Fracture Details in Spectrum Fatigue Region
Close to 90 Degree Fibers

Figure 2-193. (Continued)
 (d), (e) Crack-Growth Region Close to 0 Degree Fibers
 CD = Crack propagation direction

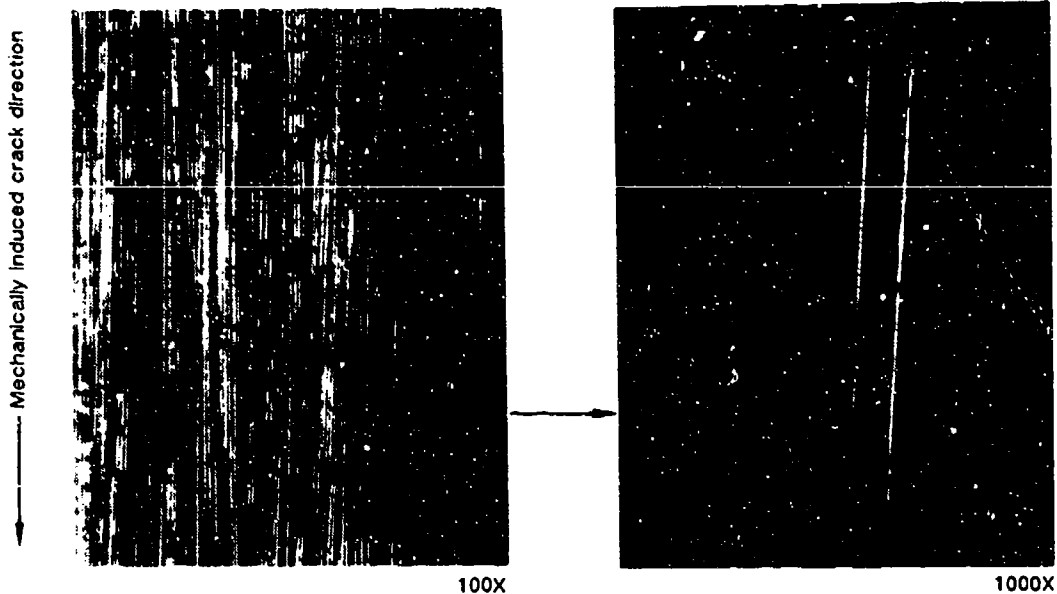
Fracture type	Interlaminar fatigue mode II shear
Ply layup	[0] 24
Test type	Fatigue C.I.S
• Test conditions	21°C, dry
• Fracture between	0/0 plies
Material	Hercules 3501-6/177°C cure AS4 fibers

Figure 2-195. Optical Photographs of Interlaminar Fatigue Mode II Shear, 0/0 Fracture, 70 F/Dry (100X and 1000X)

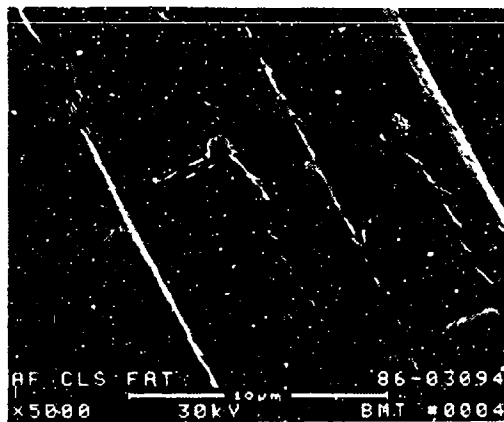
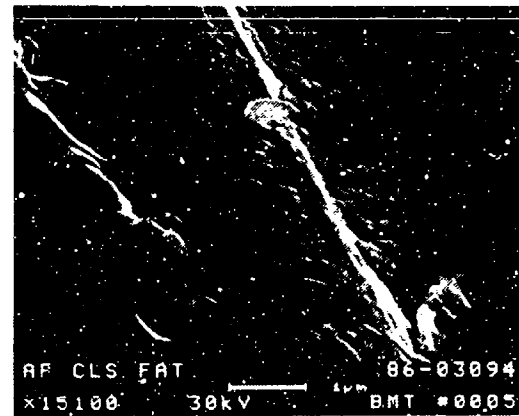
Fracture type	Interlaminar fatigue mode II shear
Ply layup	[0] 24
Test type	Fatigue CLS (80% to 20% G _{II} C)
• Test conditions	21°C, dry
• Fracture between	0/0 plies
Material	Hercules 3501-6/ 177°C cure AS4 fibers

Figure 2-196. SEM Photographs of Interlaminar Fatigue Mode II Shear, 0/0 Fracture, 70 F/Dry (5000X and 15000X)

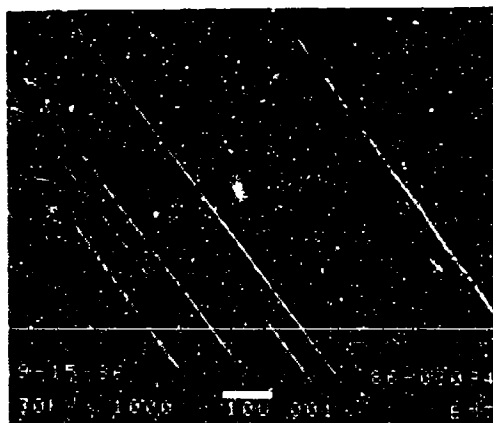
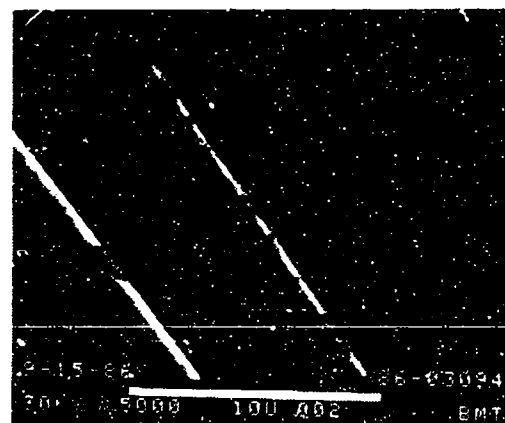
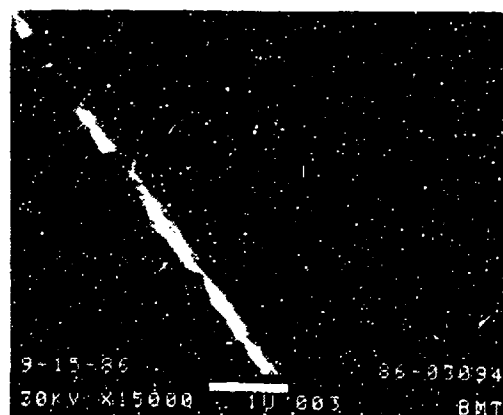
Fracture type	Interlaminar fatigue mode II shear
Ply layup	[0] 24
Test type	Fatigue CLS (80% to 40% GIIIC)
• Test conditions	21°C, dry
• Fracture between	0/0 plies
Material	Hercules 3501-6/177°C cure AS4 fibers

Figure 2-197. SEM Photographs of Interlaminar Fatigue Mode II Shear, 0/0 Fracture, 70 F/Dry (1000X, 5000X and 15000X)

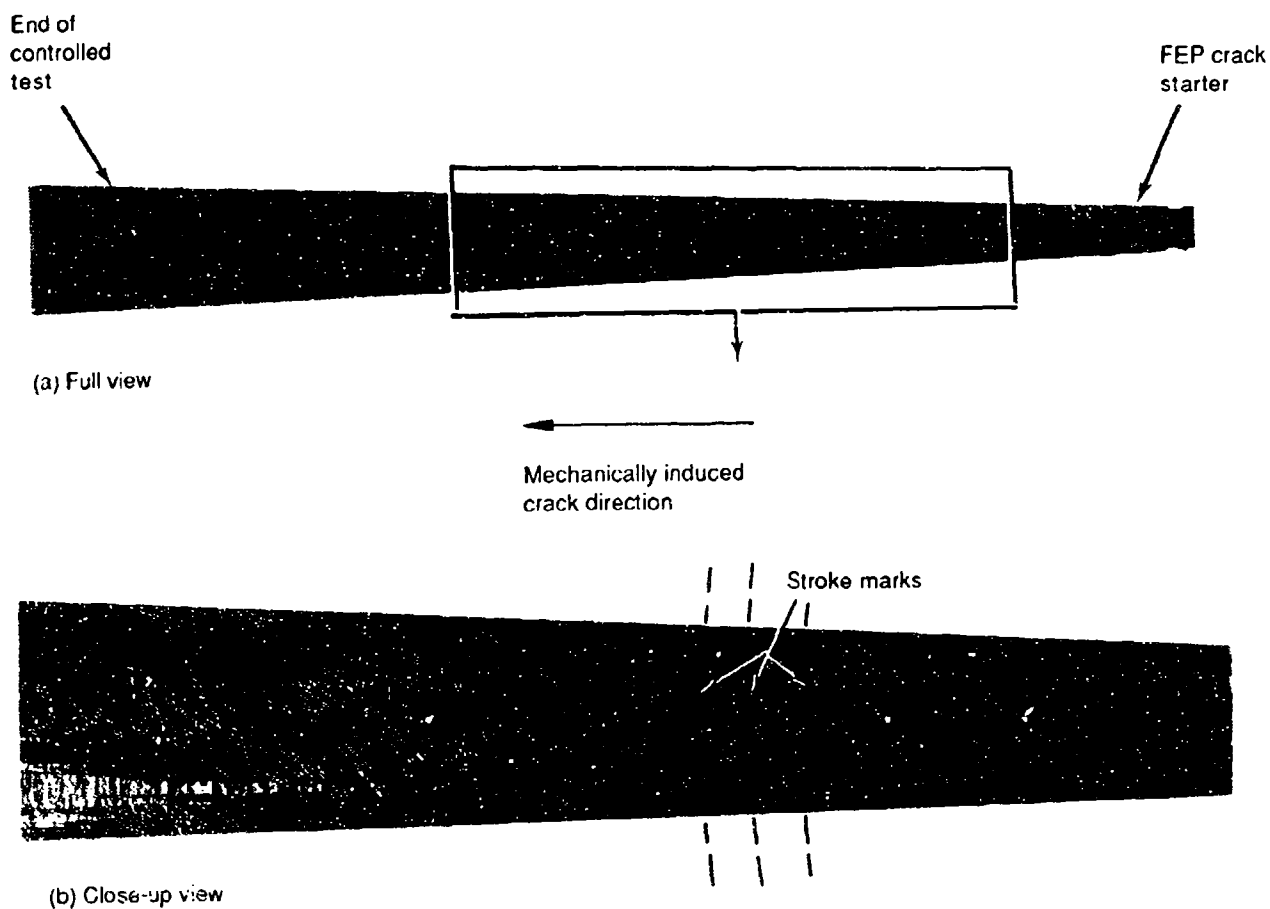
Figure 2-196. Macrophotographs of Interlaminar Mode I Tension, RT/Dry Creep, 0/90 Fracture

Visual observation revealed a smooth, glassy surface typical of an interlaminar Mode I tension fracture. There were visible crack arrest marks ("beach marks") running perpendicular to the mechanically induced crack direction (Figure 2-198). The spacing between these marks was quite consistent due to the constant loading rate throughout the creep test. Optical fractography focused on what appeared to be a striped fracture region. Due to the re-initiation of the crack, the location just after crack arrest appeared much rougher than the region just prior to it (Figure 2-199). The river marks were more readily observed in the region prior to the crack arrest.

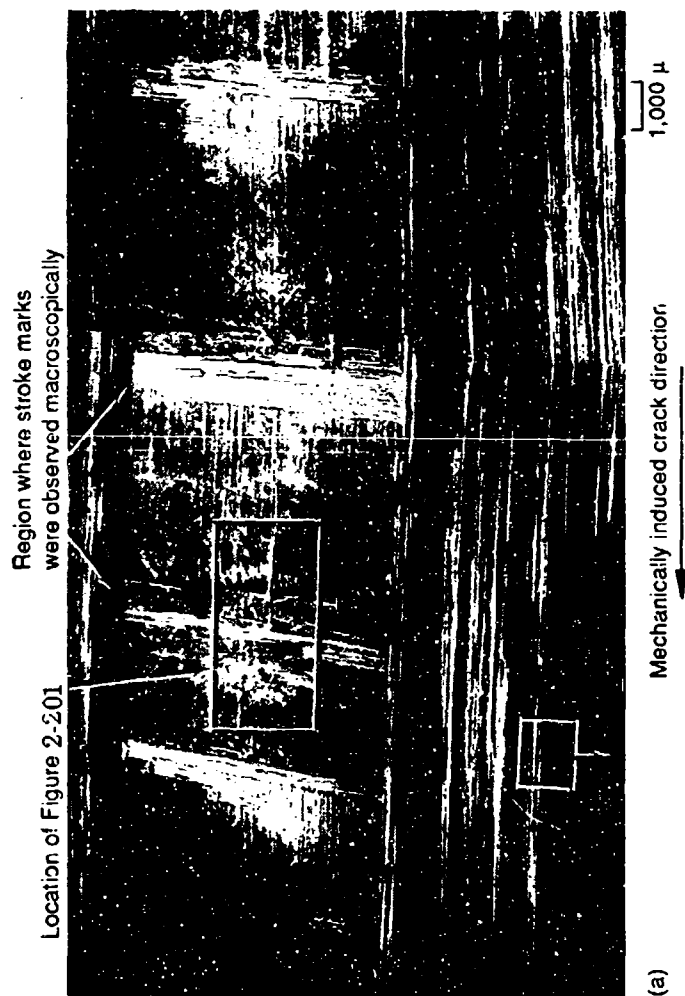
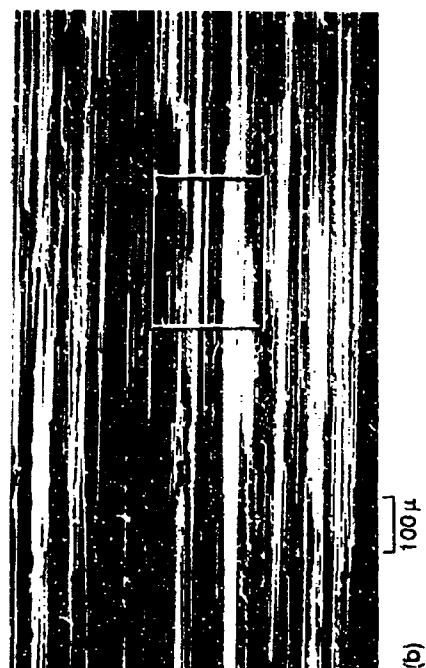
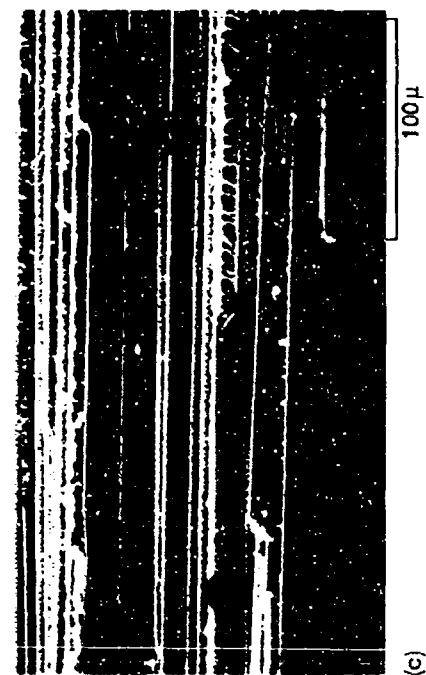
Figure 2-200. SEM Fractographs of Interlaminar Mode I Tension, RT/Dry Creep, 0.90 Fracture

SEM fractographs of the three regions of fracture were taken, including the location of the crack arrest (Figure 2-200). The fracture topography was smooth with distinct river marks just prior to the periodic crack arrest. After reinitiation of the crack, the fracture appeared uneven with very fine river marks (Figure 2-201).

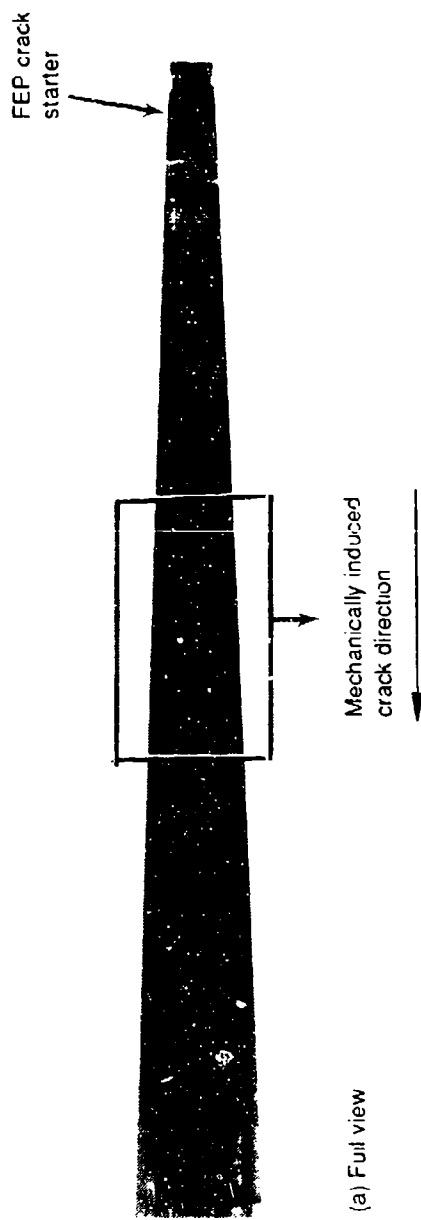
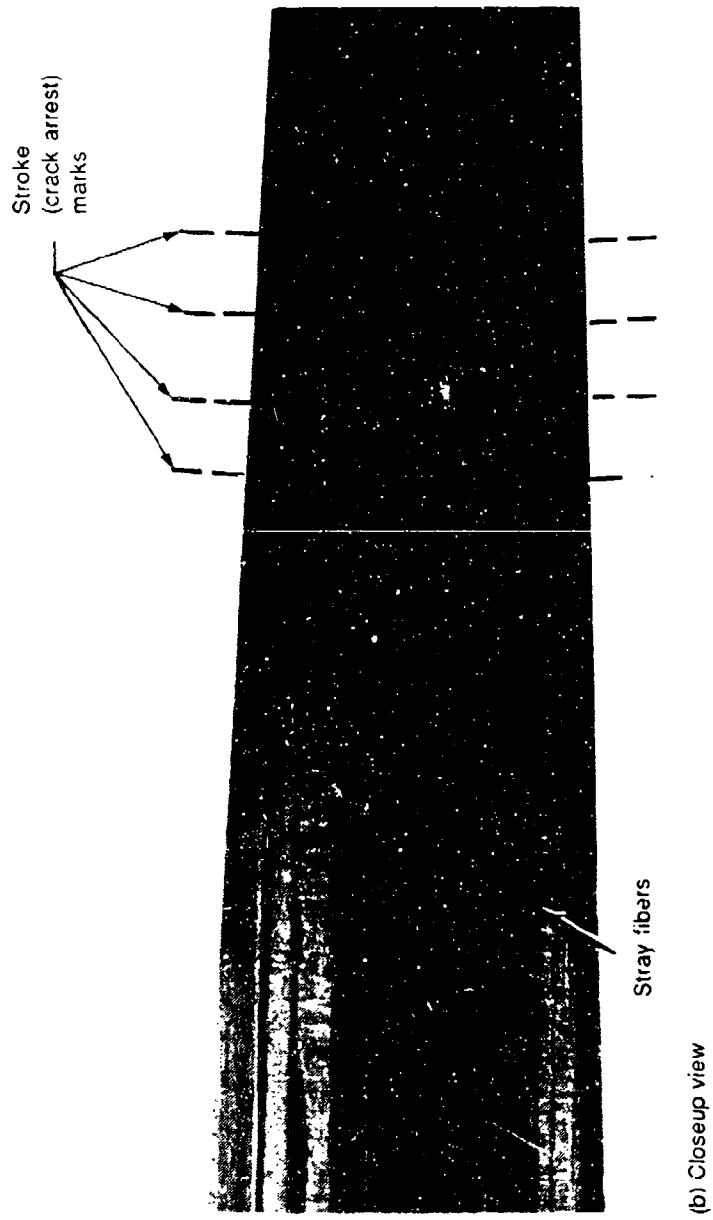
Figure 2-202. Macrophotographs of Interlaminar Mode I Tension, 270 F/Dry Creep, 0/90 Fracture

Visual observation revealed a smooth, glassy fracture surface similar to that of the RT specimen. Crack arrest marks were again observed (Figure 2-202). However, there were fragments of loose fibers on the fracture surface. These fibers may have separated from the resin matrix prematurely due to poor adhesion. The fracture topography at the region before and after the crack arrest was smooth (Figure 2-203), unlike that of the fracture created at RT. The SEM analysis confirmed the observations made during the optical analysis (Figure 2-204).

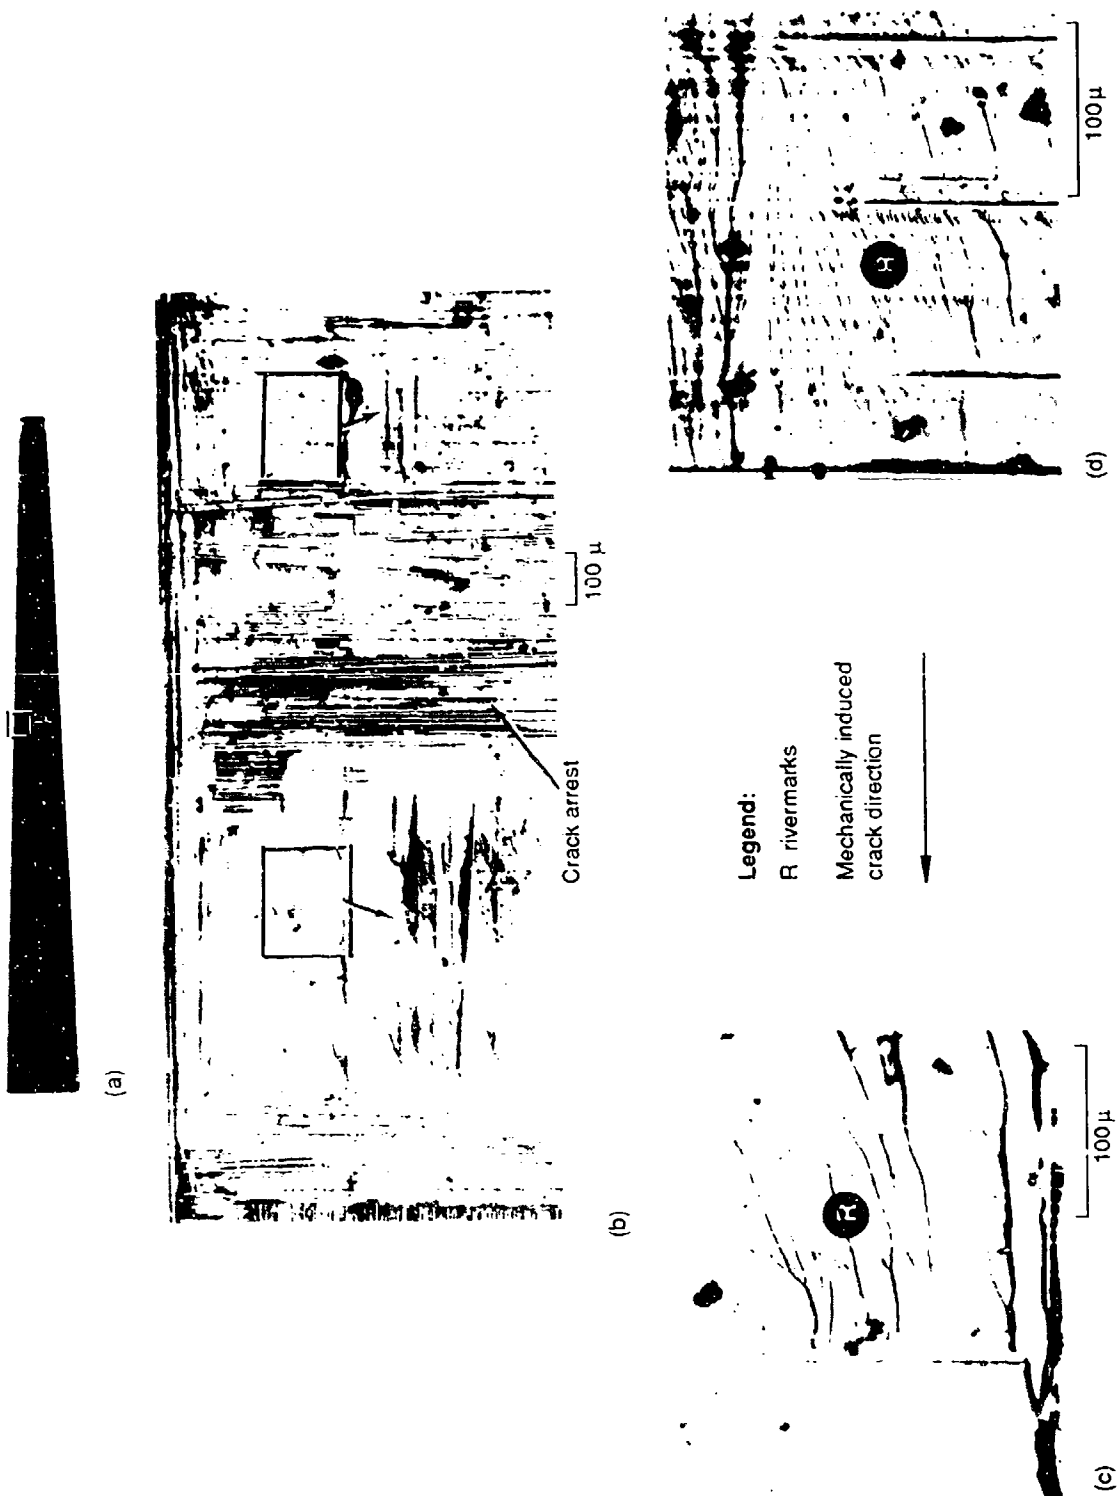
Figure 2-203. Optical Photomicrographs of Interlaminar Mode I Tension, 270 Fil/Dry Creep, 0/90 Fracture

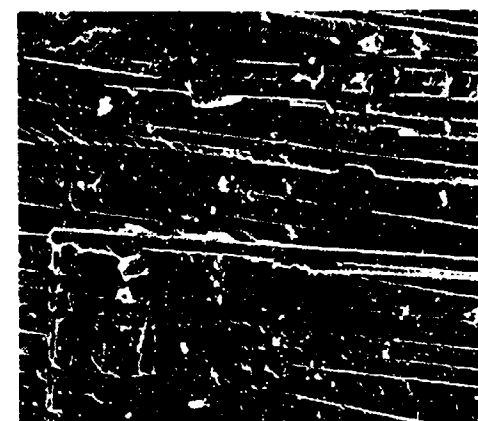
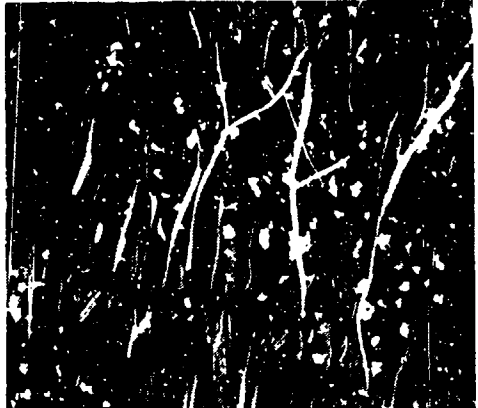
Legend:
 R rivermarks
 F fiber/matrix fracture
 Mechanically induced crack direction

Figure 2-204. SEM Fractographs of Interlaminar Mode I Tension, 270 F/Dry Creep, 0/90 Fracture

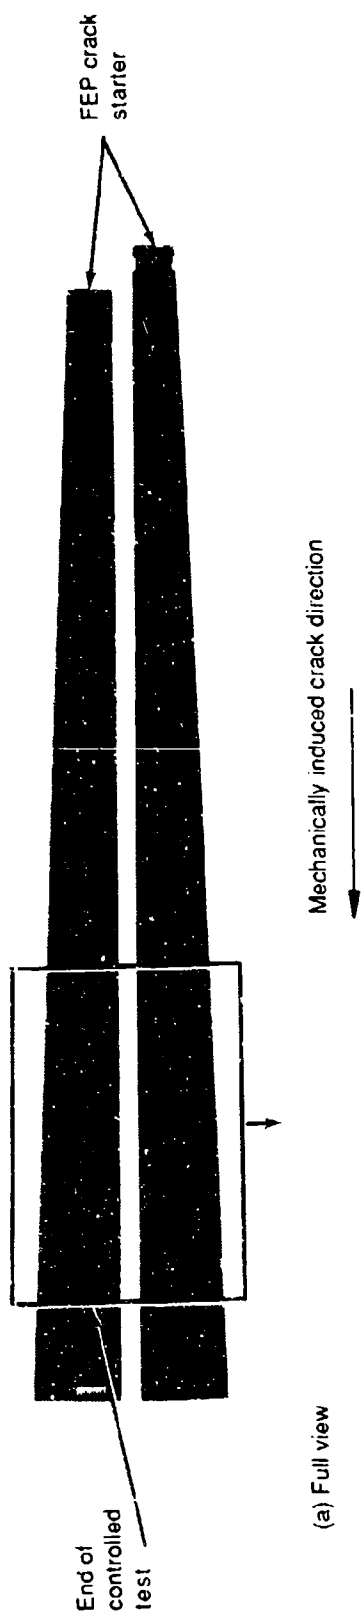
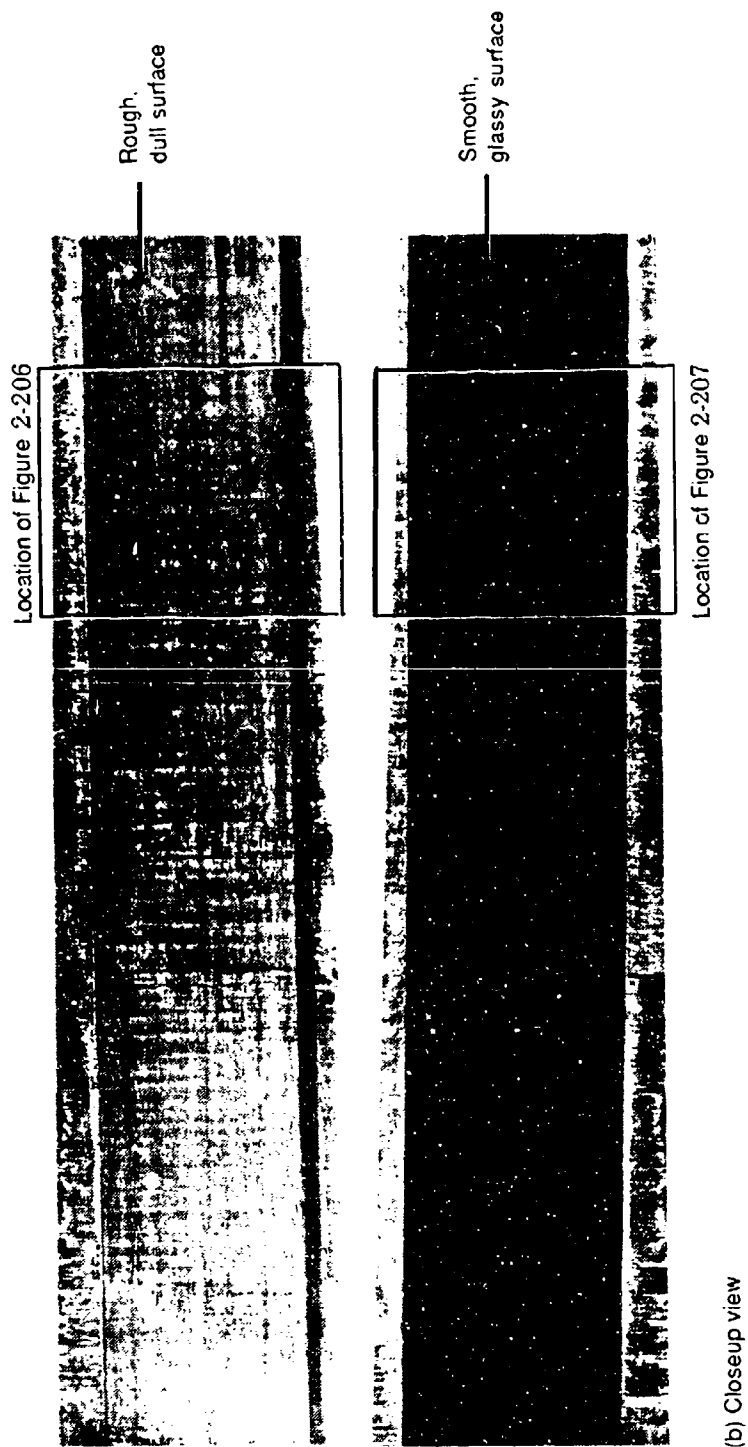
Figure 2-205. Photomicrographs of Interlaminar Mode II Shear, RT/Dry Creep, 0/90 Fracture

Visually, the mating fracture surfaces looked somewhat different: one surface was smooth and glassy, while the other was rough and dull (Figure 2-205). Crack arrest marks were observed on the fracture surfaces at the ends of and at the center of the specimen. SEM fractographs revealed that the glassy surface consisted largely of scallops with some hackles (Figure 2-206), and the rough surface exhibited mainly hackles with some scallops (Figure 2-207).

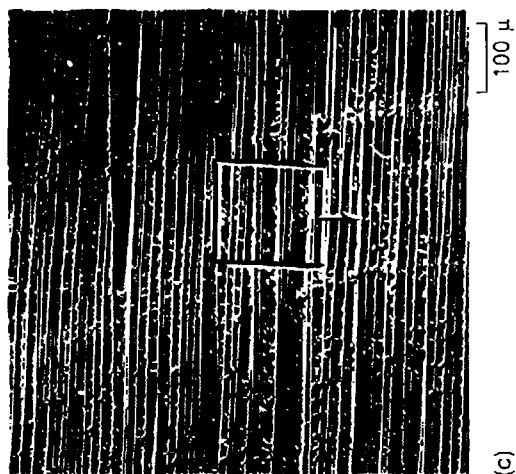
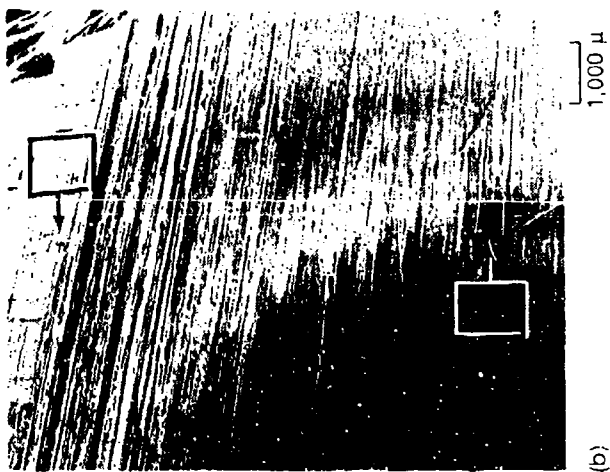
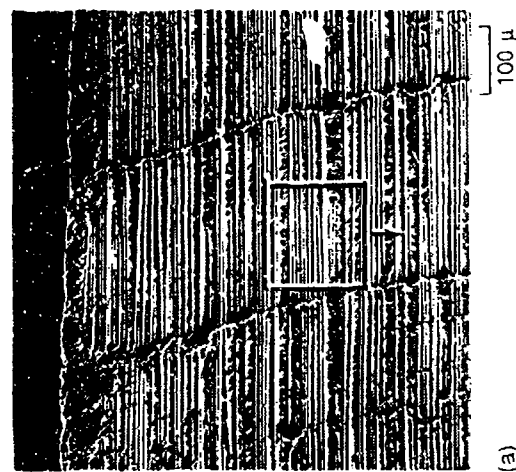
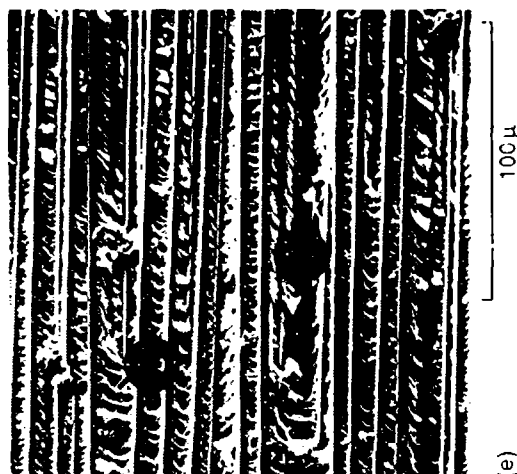
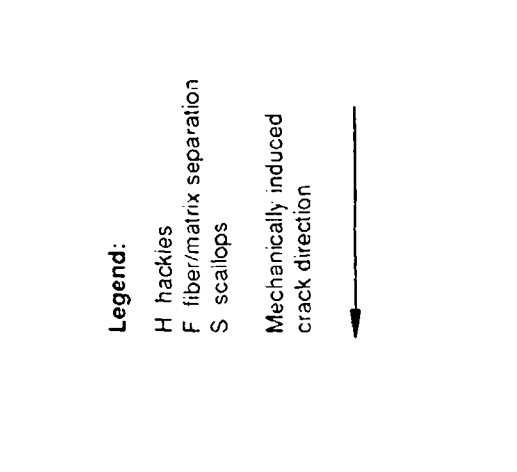
- H hackles
- F fiber/matrix separation
- S scallops
- Mechanically induced crack direction

Figure 2-207. SEM Fractographs of Interlaminar Mode II Shear, RT/Dry Creep, 0/90 Fracture Showing Glassy Surface
(Area Shown in Figure 2-205b)

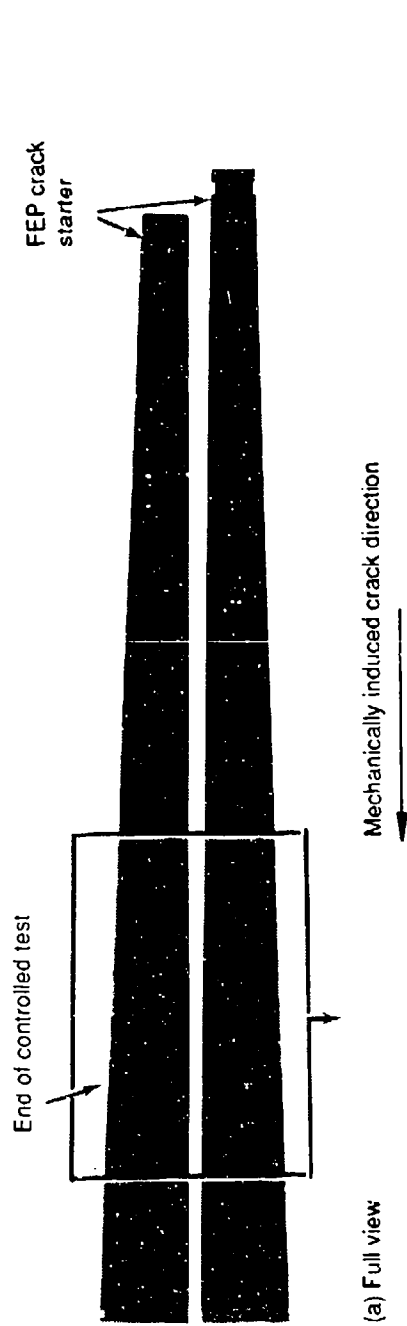
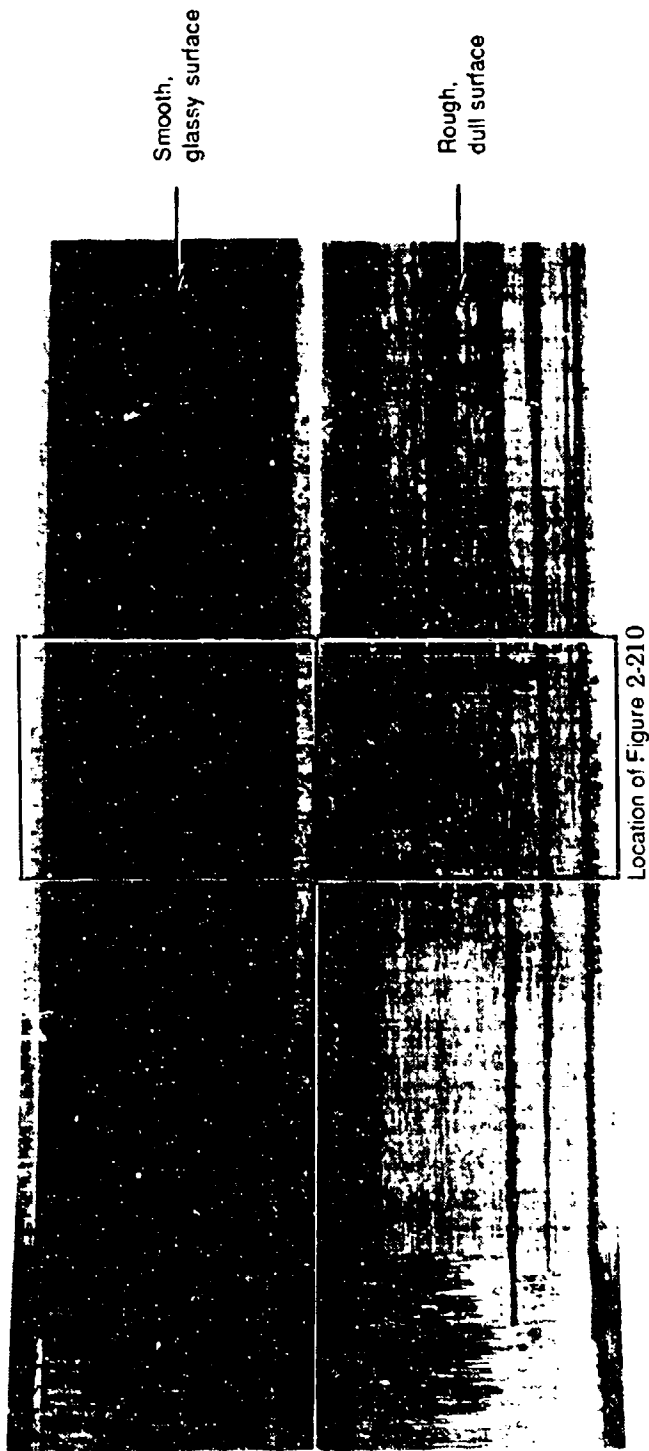
Location of Figure 2-209

Location of Figure 2-210

Fracture 2-208. Photomicrographs of Interlaminar Mode II Shear, 270 F/Dry Creep, 0/90 Fracture

Visual examination revealed a fracture with a smooth and glassy surface on one of the mating sides and a rough and dull surface on the other side (Figure 2-208). This was similar to the

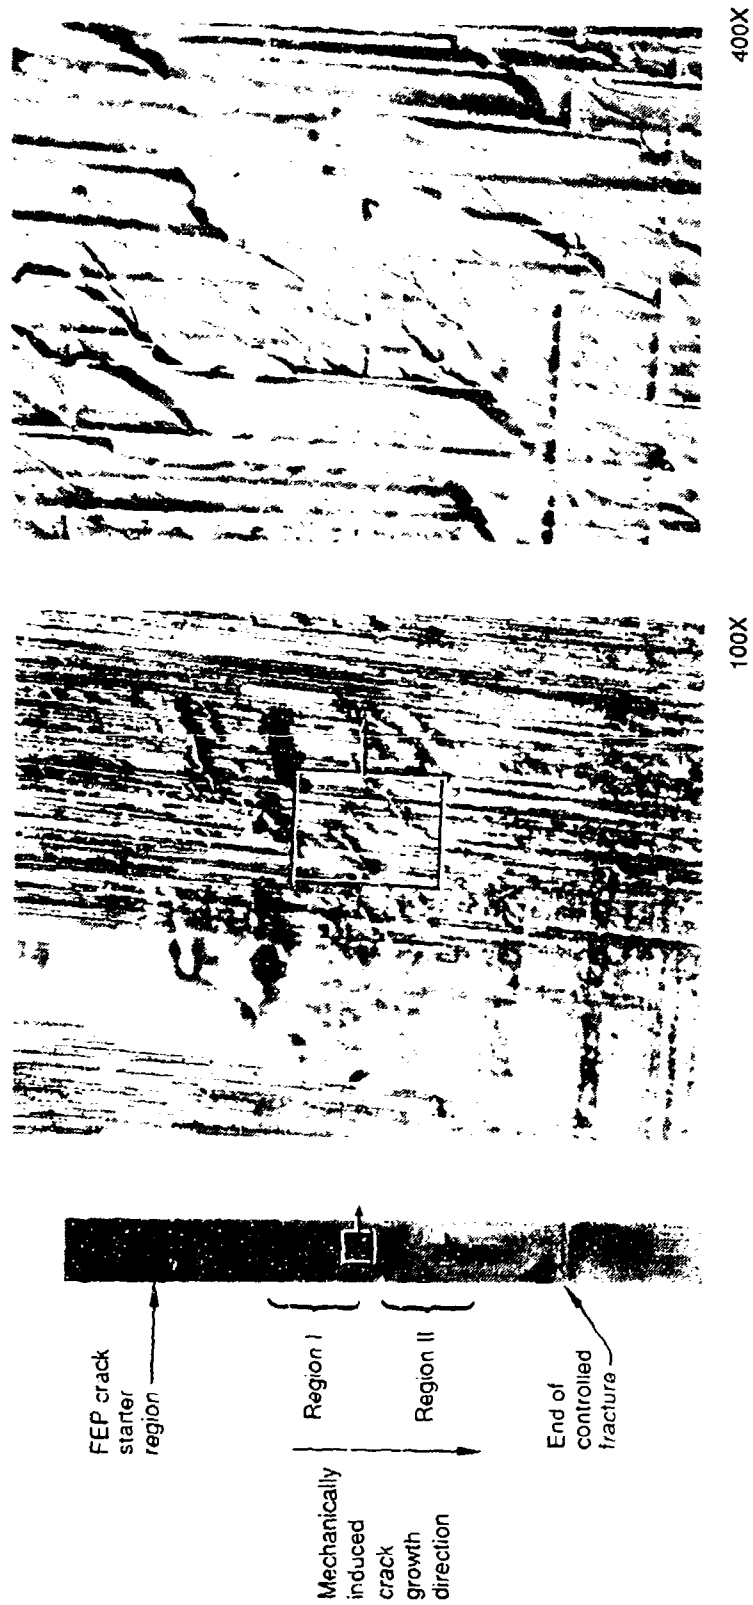
Figure 2-211. Optical Photomicrographs of Interlaminar Mode I Tension, High Rate, Room Temperature Fracture Between the 0/90 Plies

F fiber matrix
R rivermark
M matrix fracture

Visual observation of the DCB Mode I tension specimen, tested under conditions resulting in a high rate of fracture, revealed fractures somewhat different from those in a DCB/RT interlaminar Mode I tension specimen tested at constant rate. Due to the very rapid crack propagation, the fracture surface did not exhibit the clear macroscopic crack arrest marks which are characteristic of slow crack growth. In some locations, fiber splinters were peeled away from the matrix. Under the optical microscope, a cleavage fracture was observed with numerous rivermarks showing an overall crack direction (Figure 2-211).

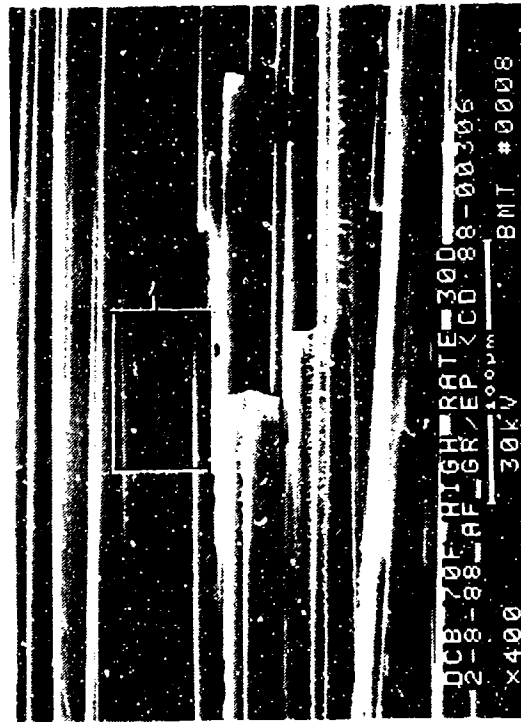
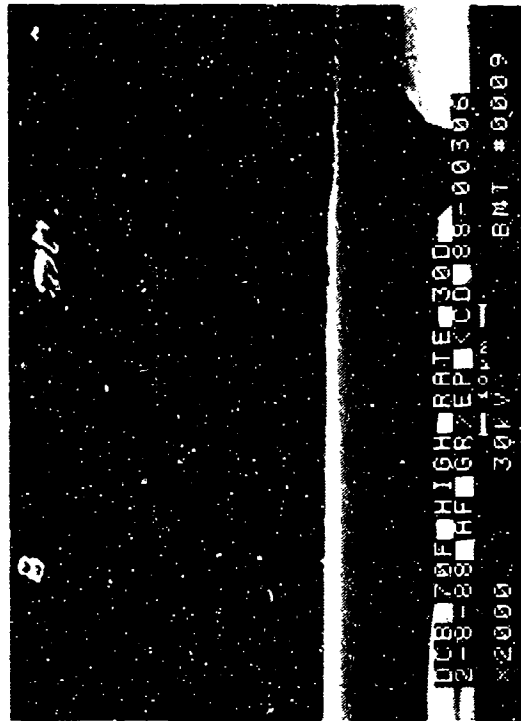
20X

400X

Figure 2-212. SEM Fractographs of Interlaminar Mode I Tension, High Rate, Room Temperature Fracture (Region I of Figure 2-211)

To illustrate the different rates of fracture, two regions on the specimen were documented and analyzed. Region I was created by the initial projectile, and Region II was created by a second projectile penetration. SEM analysis showed that Region I experienced a lower energy fracture than Region II, as evidenced by its rougher surface and more mixed mode fracture (Figure 2-212). This may be a result of the initially delaminated portion driving the crack at a higher rate. There were also many fiber splinters and many areas of 90 degree intralaminar fracture in Region II (Figure 2-213).

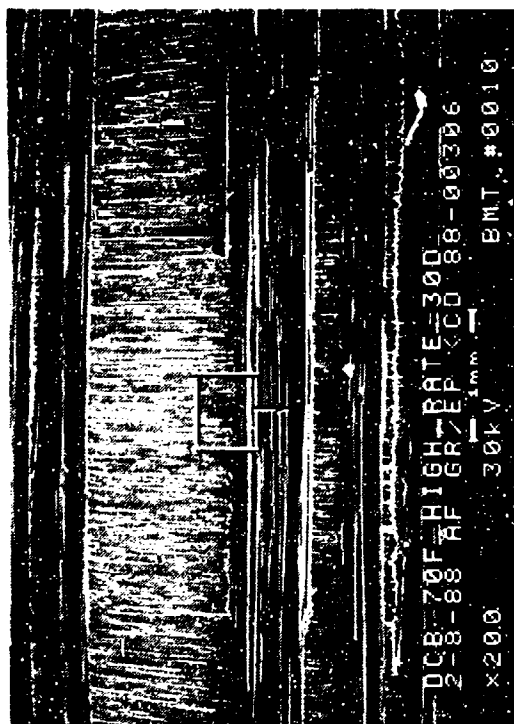
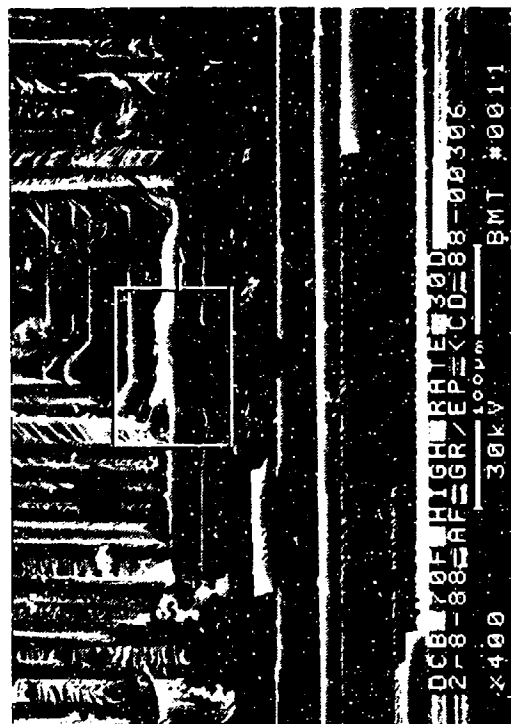
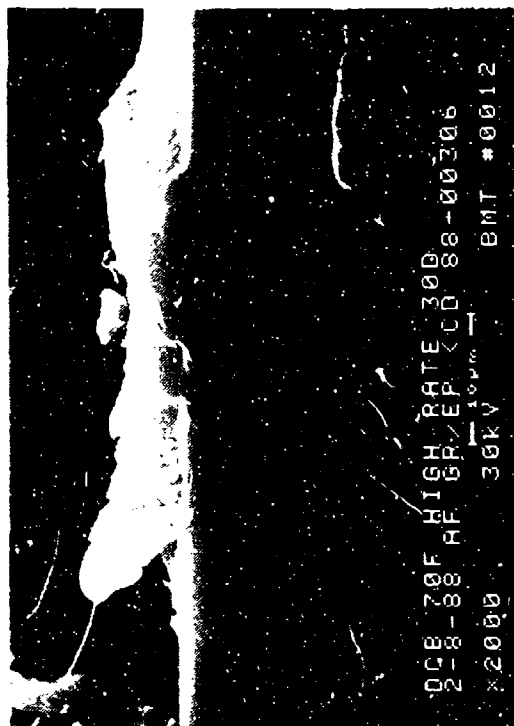
- R rivermark
- H hackle
- F fiber matrix separation
- M matrix fracture

Figure 2-213. SEM Fractographs of Interlaminar Mode I Tension, High Rate, Room Temperature Fracture (Region II of Figure 2-211)

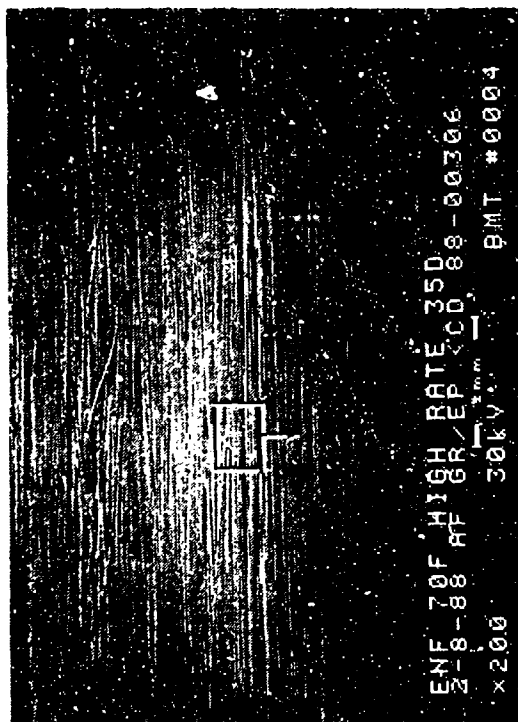
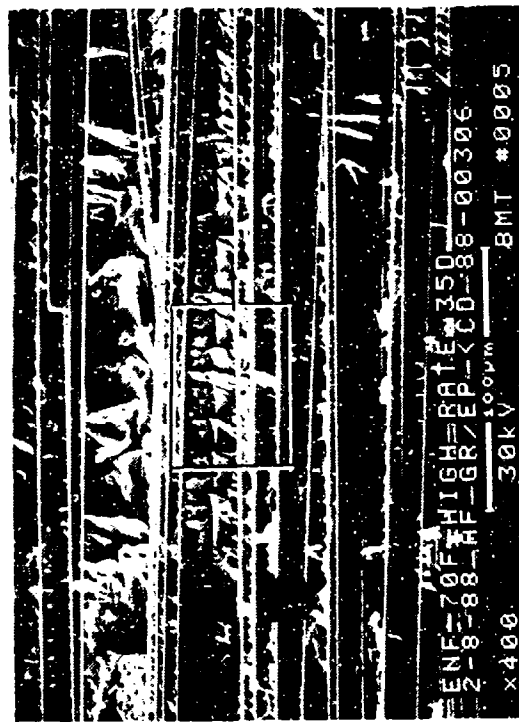
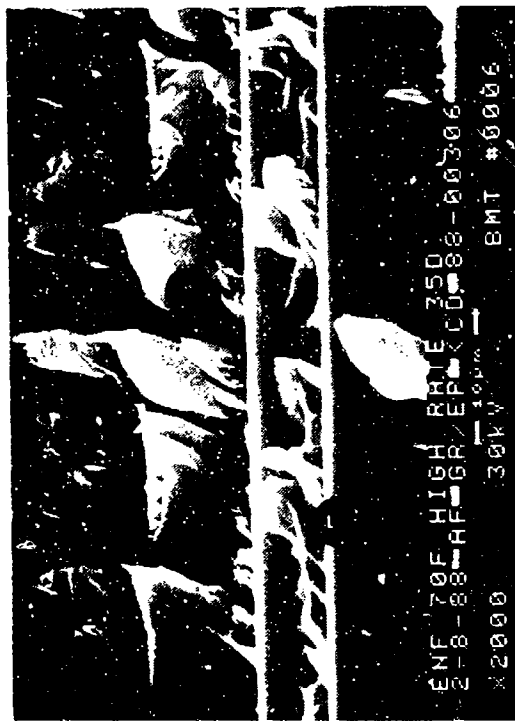
Figure 2-215. SEM Fractographs of Interlaminar Mode II Shear, Room Temperature, High Rate Fracture (Region I of Figure 2-214)

Optical microscopy of the fracture surface showed a difference between the high rate specimen and the typical ENF specimen tested at constant rate (Figure 2-214). Due to the very rapid fracture, hackles were formed in various tilts and shapes; at slower crack growth rates, the hackles tend to form parallel to one another. Regions created by initial and secondary projectile penetration (resulting in different crack growth rates) exhibited no distinctly different features (Figures 2-215 and 2-216).
